Technical Report

DEEP-OCEAN BIODETERIORATION
OF MATERIALS — PART VI. ONE
YEAR AT 2,370 FEET

U. S. NAVAL CIVIL ENGINEERING LABORATORY
Port Hueneme, California

Technical Report R-525

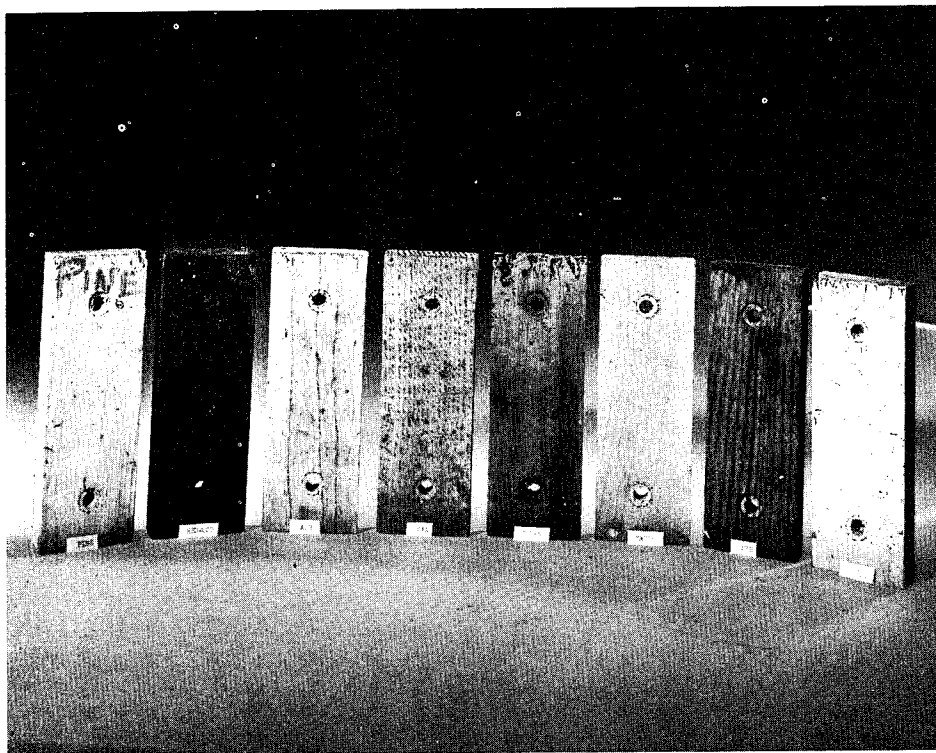
Wood Panels. Various kinds of untreated wood panels (1/2 x 2 x 6-inch) such as pine, fir, ash, maple, cedar, oak, and redwood were exposed to determine the effects of marine organisms on different woods. All the wood panels were attacked by marine borers and sustained light to heavy damage. Redwood and cedar were the most severely damaged; maple, pine, oak, and ash were moderately damaged; and fir sustained the lightest damage (Figures 16 & 17).

Figure 16. Various types of wood panels (exterior).

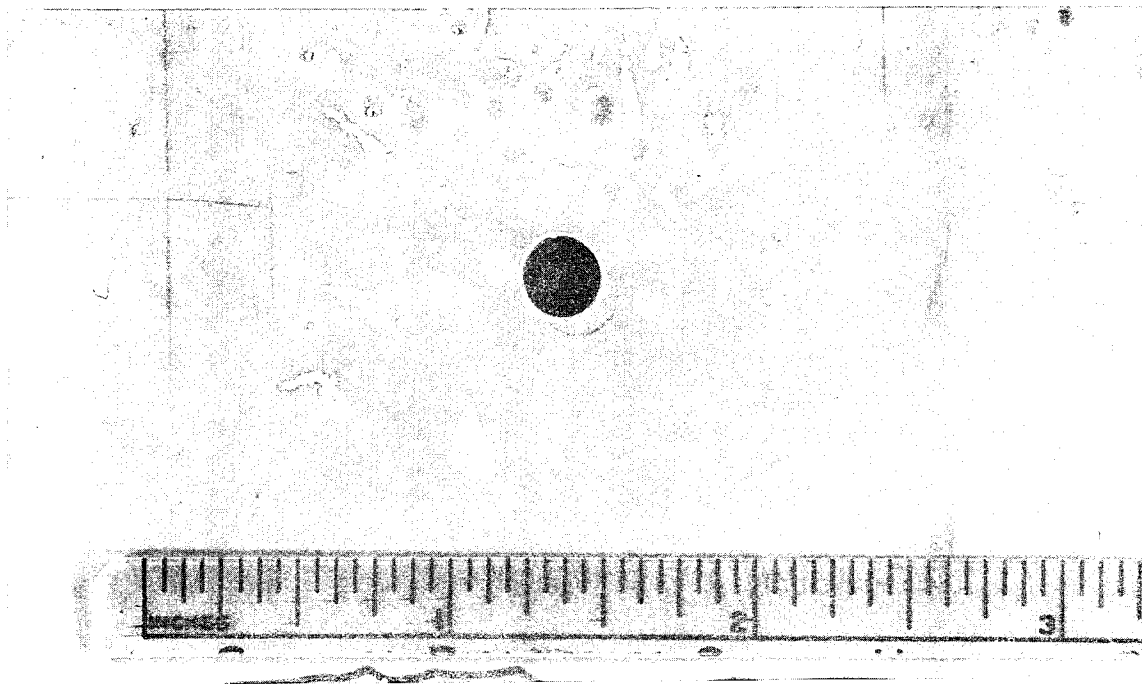
Figure 20. Phenolic laminated plastic sheet damaged by borers in an area which was in contact with wood. Compare size of damage to 1/4-inch-diameter bolt hole.

The surface of the phenolic laminated plastic sheet where the wood panels were attached was damaged by these borers (Figure 20). The borers had attacked the wood first and had then continued to bore into the plastic. Deep sea fungi were not found in any of the 1/2x2x6-inch panels which were exposed about 3 feet above the sediment layer. However, the surfaces of these wood panels were slightly deteriorated by bacterial action.

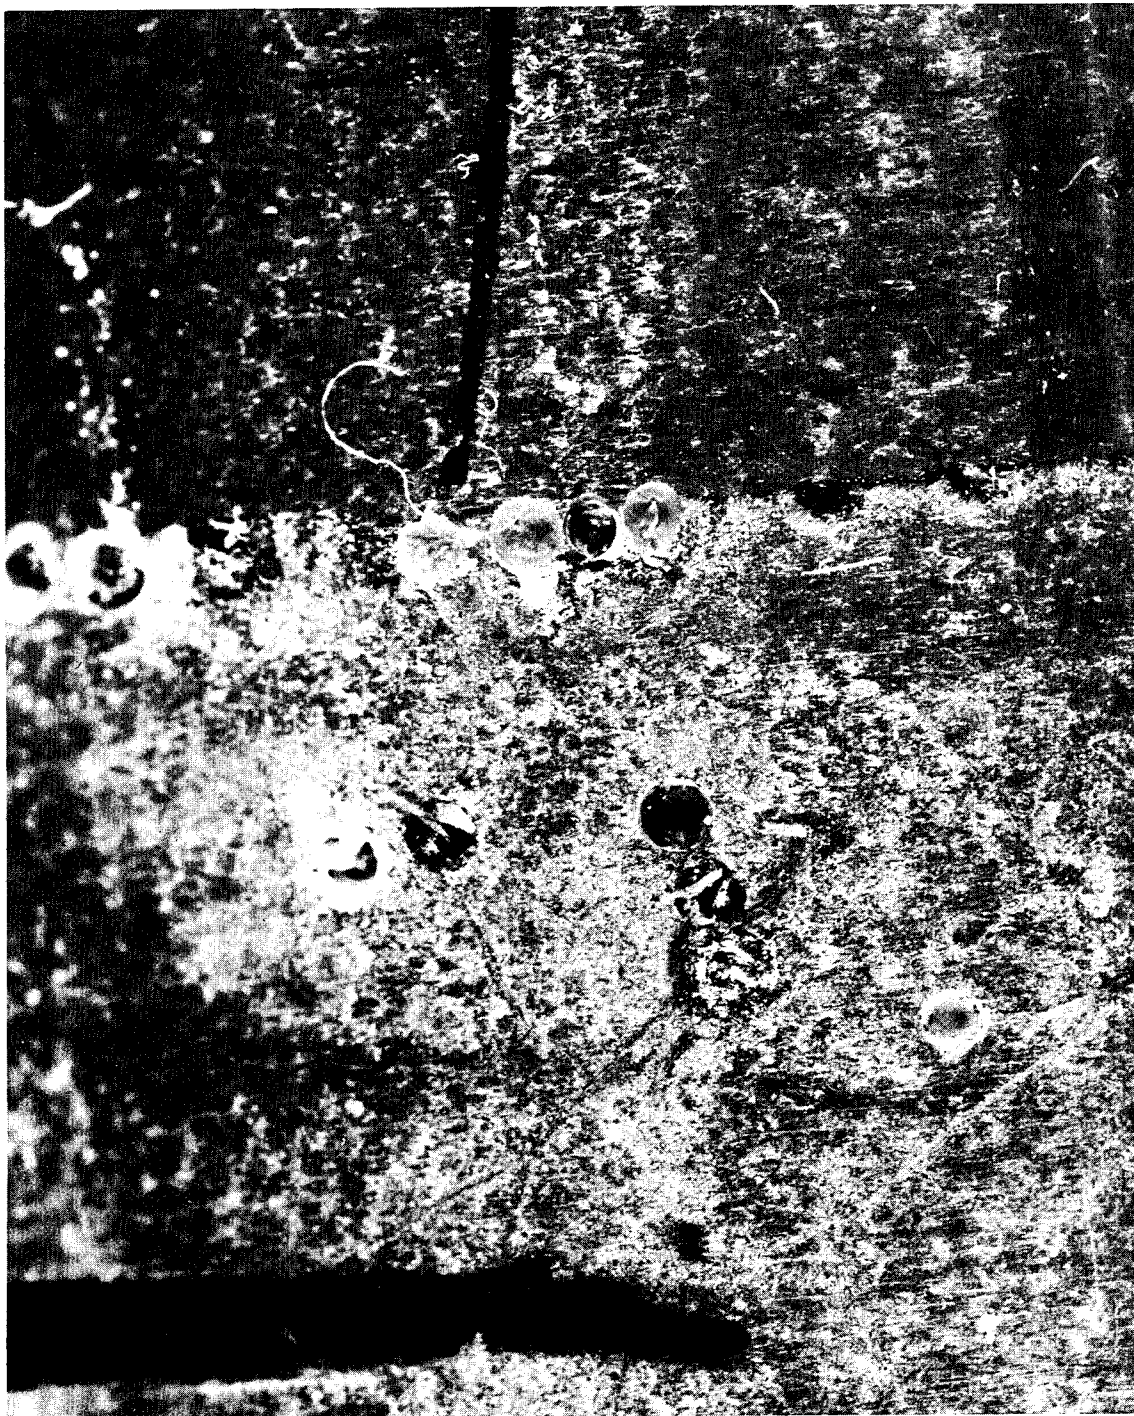
Figure 30. Photomicrograph of borer damage on the surface of a polystyrene plastic rod. The 1/32-inch-diameter borers are visible in holes.

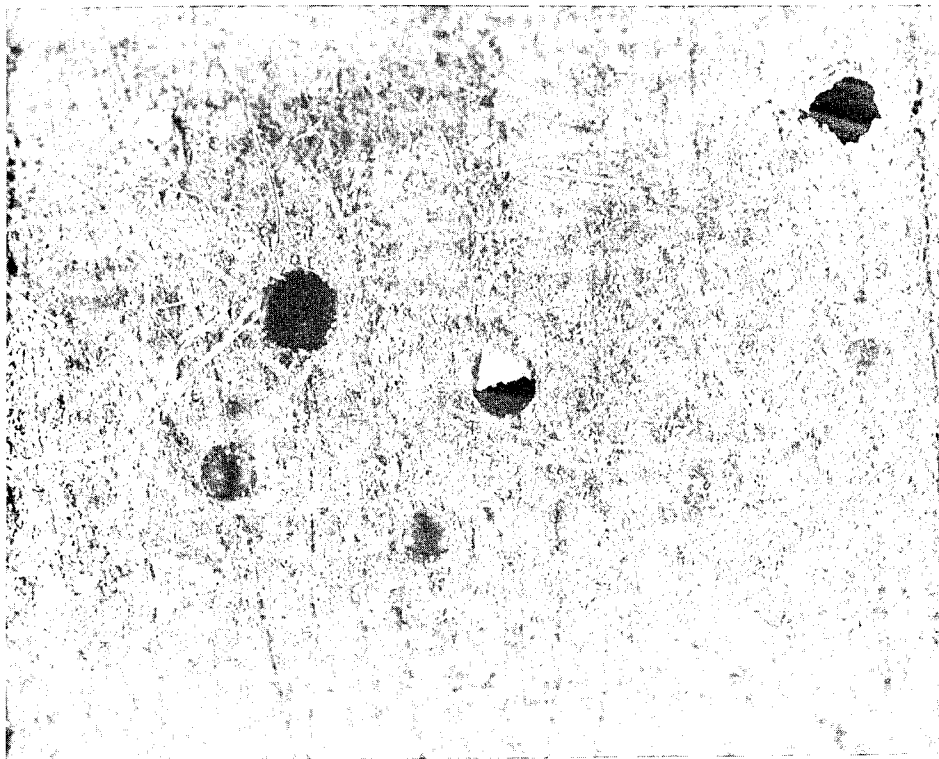
Figure 32. Photomicrograph of borer damage on the surface of a phenolic laminated plastic rod. A 1/16-inch-diameter borer is visible in a hole.

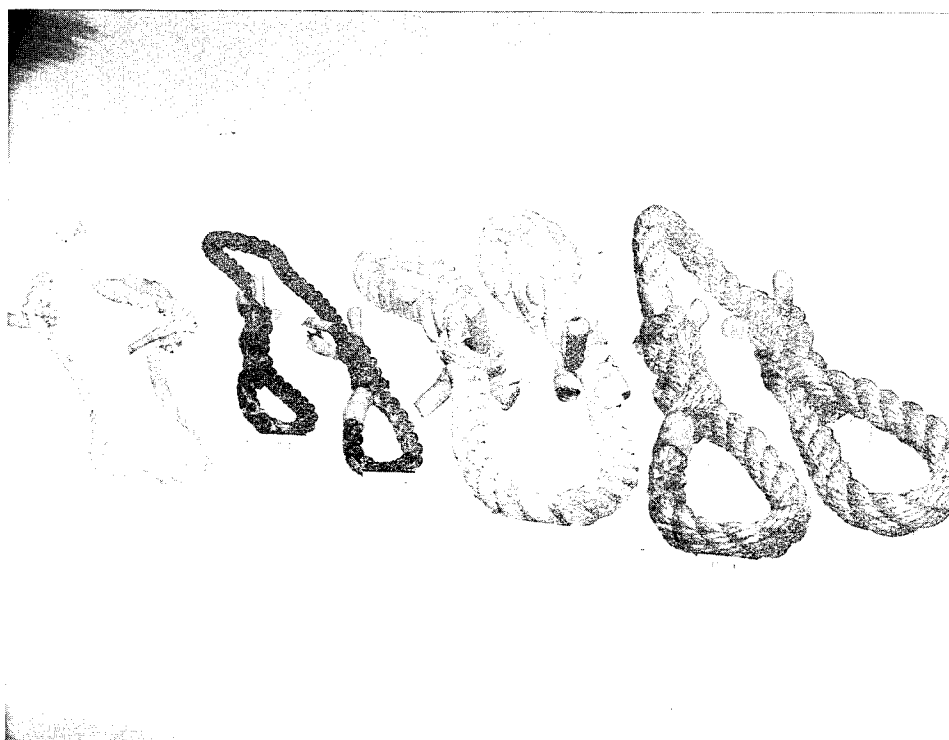
Figure 42. Rope specimens which were placed inside a plastic test chamber.

Generally, the materials placed in the plastic tube were not deteriorated as severely as those materials exposed outside the tube (Figure 42). The fir panel was moderately attacked by borers, with some borers measuring about 1/4 inch in diameter. The fibers of cotton and manila rope specimens were slightly deteriorated by micro-organisms. Borers were not found in manila rope specimens. The synthetic rope specimens were in excellent condition. The various electrical cable insulations (15 mils thick) on No. 16 wire were not affected. However, a large section of the white polyvinyl chloride insulation had turned black after being exposed to the hydrogen sulfide in the mud (Figure 43). This change occurred probably because there may have been small quantities of lead in the PVC insulation, and this lead had reacted with hydrogen sulfide to form lead sulfide, which is black. Small test strips of white polyvinyl chloride materials such as this could probably be used to detect the presence of hydrogen sulfide in an anaerobic environment, especially in areas where conventional testing devices cannot be placed or used for detecting hydrogen sulfide.
